Bear River Semi-Autonomous Salmon Enumeration Fence - 2021

Prepared for the British Columbia Salmon Restoration and Innovation Fund by:
Janvier Doire¹, Keith West² and Alicia Fernando³

June 2022

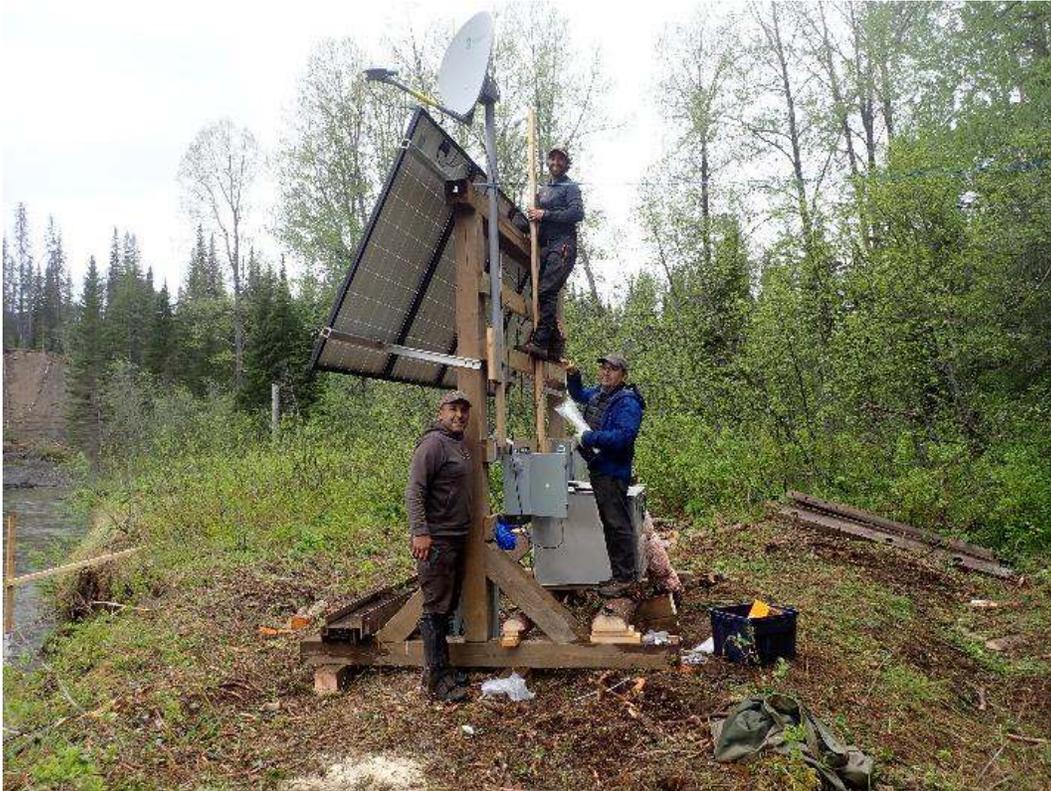
Figure 3. Photo of the installation of the solar power and satellite communications systems structure on the Bear River. June 3, 2021.

The installation of the semi-autonomous salmon enumeration fence was completed during two trips to the Bear River. During the first trip in early June 2021, the solar power and satellite communications systems were mobilized and installed at the site identified in 2020 (Figures 2 and 3). Following observations made during winter 2020-2021 at the Kitwanga smolt fence site, the height of the solar structure was increased to over 10' to prevent accumulating snow from shading the solar panels during winter (Figure 3). All remote monitoring systems were made operational during this trip (Figure 4).

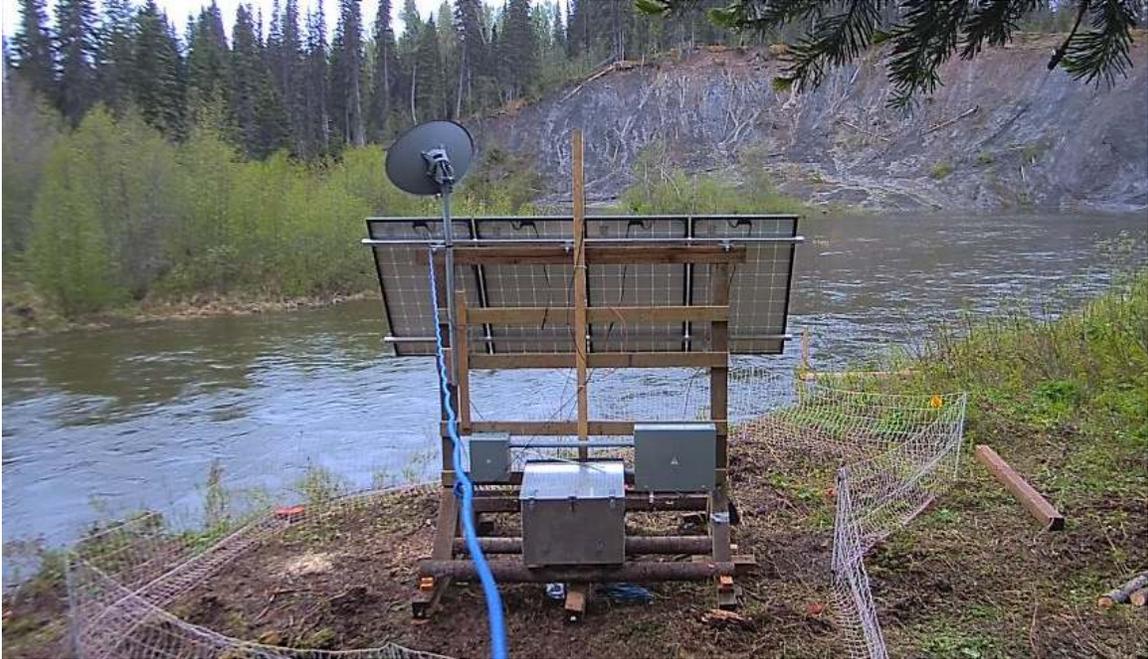
Figure 4. Photo of the solar power and satellite communications systems structure with the Bear River in the background. Photo taken remotely on June 4, 2021.

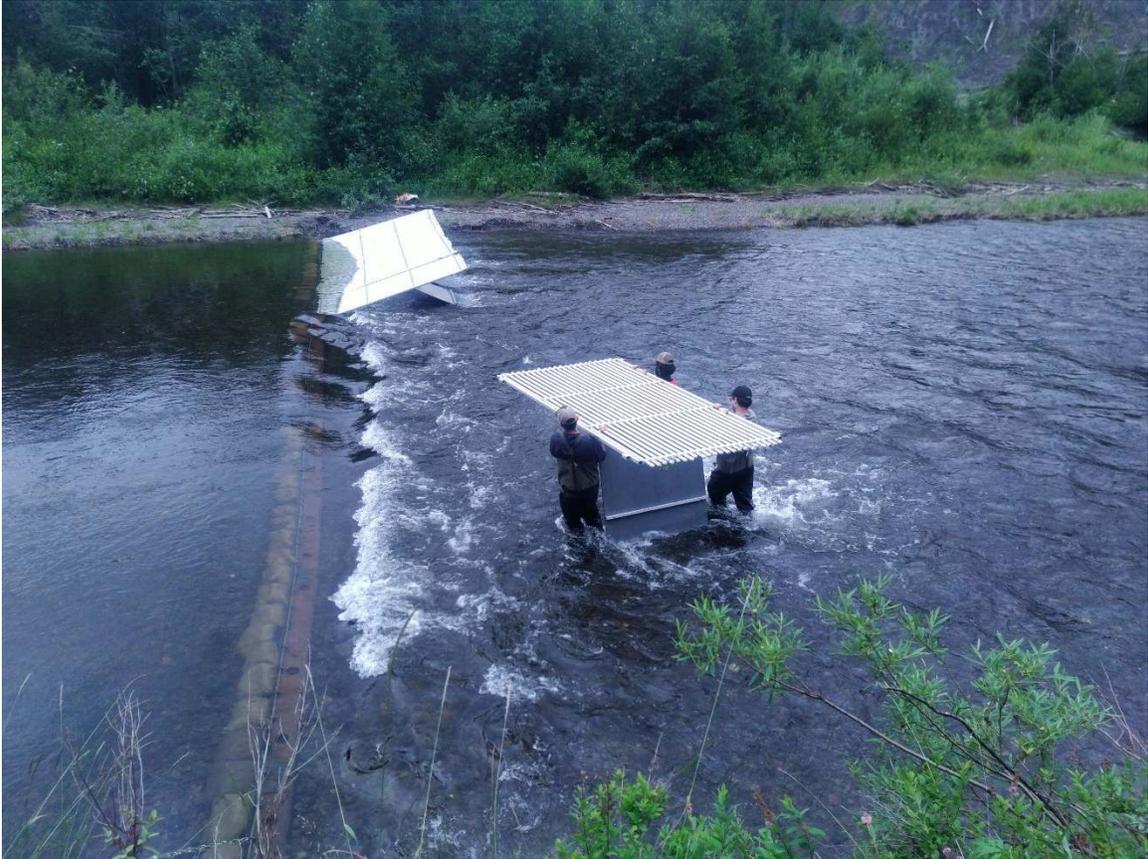
Figure 5. Photo of the fish enumeration fence installation on the Bear River. July 28, 2021.

In late July 2021, a second trip to the Bear River was made to install the salmon enumeration fence (Figure 5), the fish/camera box (see Doire and Fernando 2021 for details) and the autonomous fish enumeration system (see Doire and Fernando 2021 for details). The enumeration fence is a modular resistance board design (Figure 6). It consists of fourteen (14) 5'x10' welded aluminum square tubing frames with 10' PVC pickets through aluminum stringers (Figure 7). The fence sill is made of 9' heavy steel I-beams (Figure 7) bolted together across the river. The fence panels are attached to the fence sill using a combination of eye-bolts, shackles, and galvanized steel cable running through tabs along the I-beams sill (Figure 8). The steel I-beam fence sill was anchored into the riverbed using duckbill anchors and chains (Figure 9) and the fence panels were locked together using pieces of bent rebar. The resistance boards to lift the fence panels using the water current were constructed of 4'x4' pieces of 1/2" plywood. Burlap sandbags were positioned in front of the fence sill to prevent erosion under the sill (Figure 8). The fence was fish tight on July 28, 2021 (Figure 10). The fish box housing the high definition underwater camera and the LED light was integrated into one panel of the fence, where the greatest depth was observed (Figure 11). The fish box was anchored using two duckbill anchors and two threaded metal rods and nuts driven into the riverbed (Figures 11 and 12). The autonomous video fish enumeration system and the remote monitoring system were fully operational on July 29, 2021 (Figures 13 to 15). An electric fence was installed around the solar power and communications systems structure to deter animals from getting too close to the structure and potentially causing damages (Figure 14).

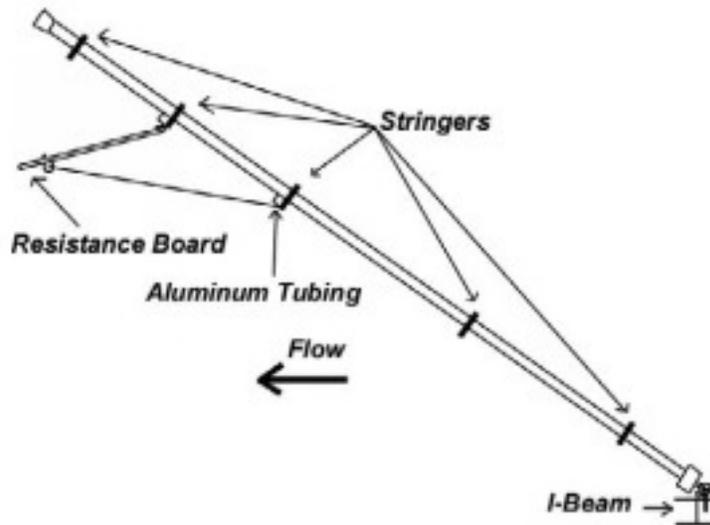
Figure 6. Side view schematic of a resistance board fence panel with aluminum frame/stringers, PVC pickets and steel I-beam sill. From Scace *et al.* 2007.

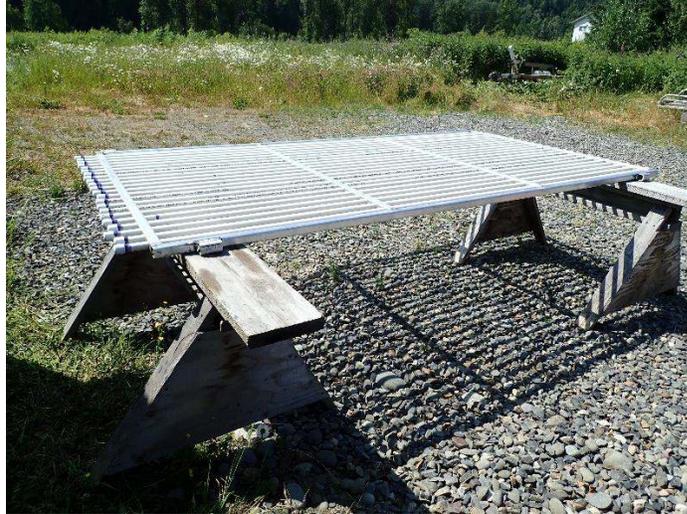
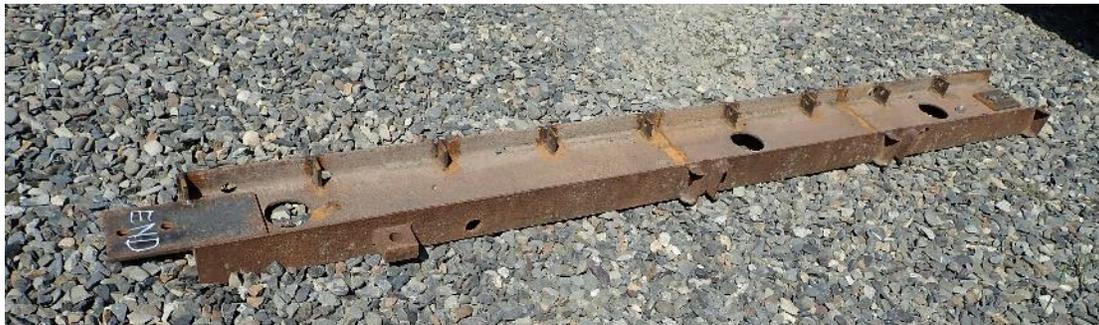
Figure 7. Photo of one of the fence panels (top) and one of the heavy steel I-beams (bottom) used at the Bear River.

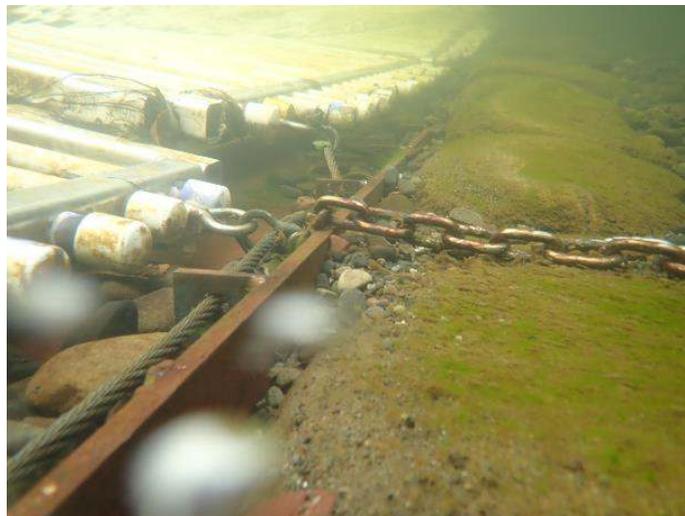
Figure 8. Photo showing how the fence panels are attached to the fence sill using a galvanized cable running through tabs along the fence sill, shackles and eye-bolts. Sandbags in front of the sill protect from erosion. The chain ties the fence sill to a duckbill anchor.

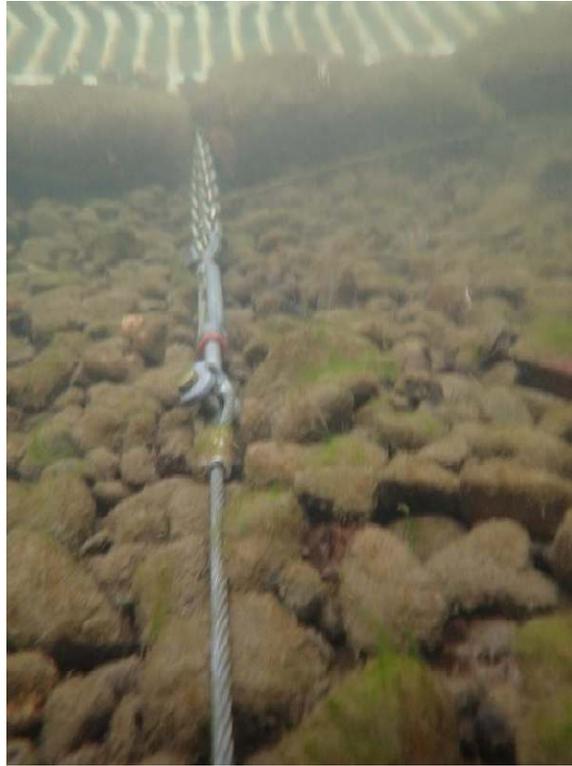
Figure 9. Photo of a duckbill anchor cable, turn buckle and chain anchoring the fence sill.

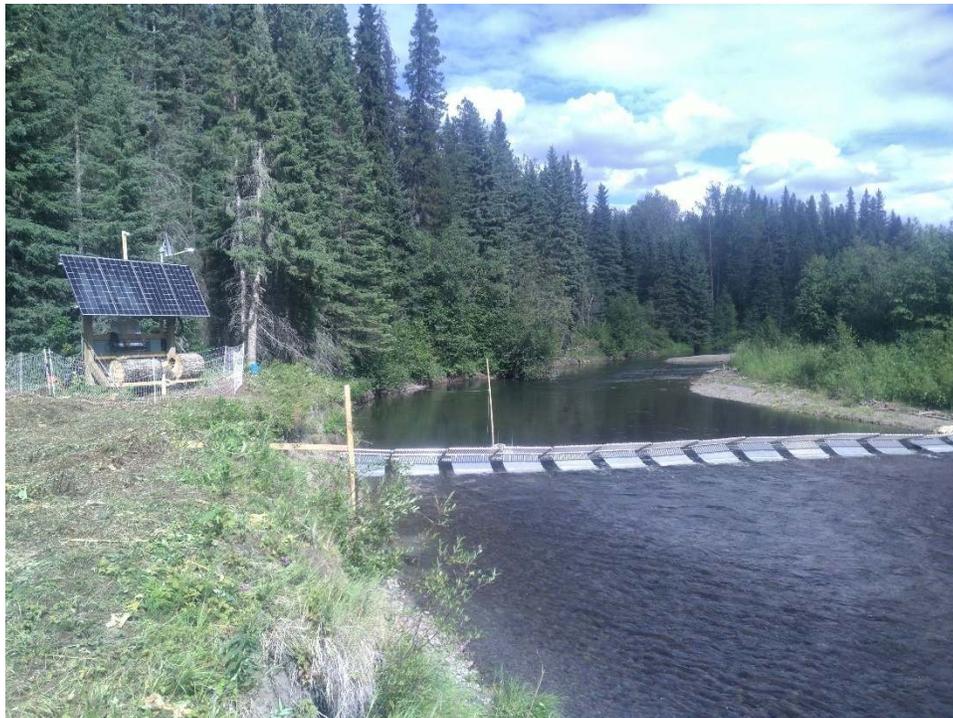
Figure 10. Photo of the assembled salmon enumeration fence, and solar power and satellite communications systems structure on the Bear River. July 29, 2021.

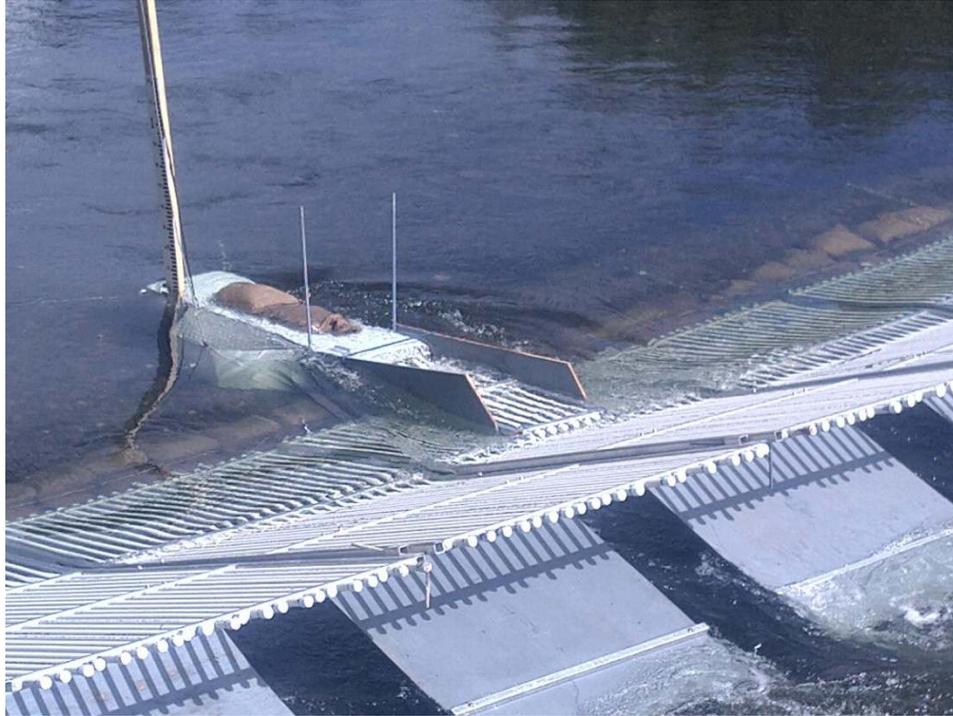
Figure 11. Photo of the fish/camera box integrated into the enumeration fence at the Bear River. July 29, 2021.

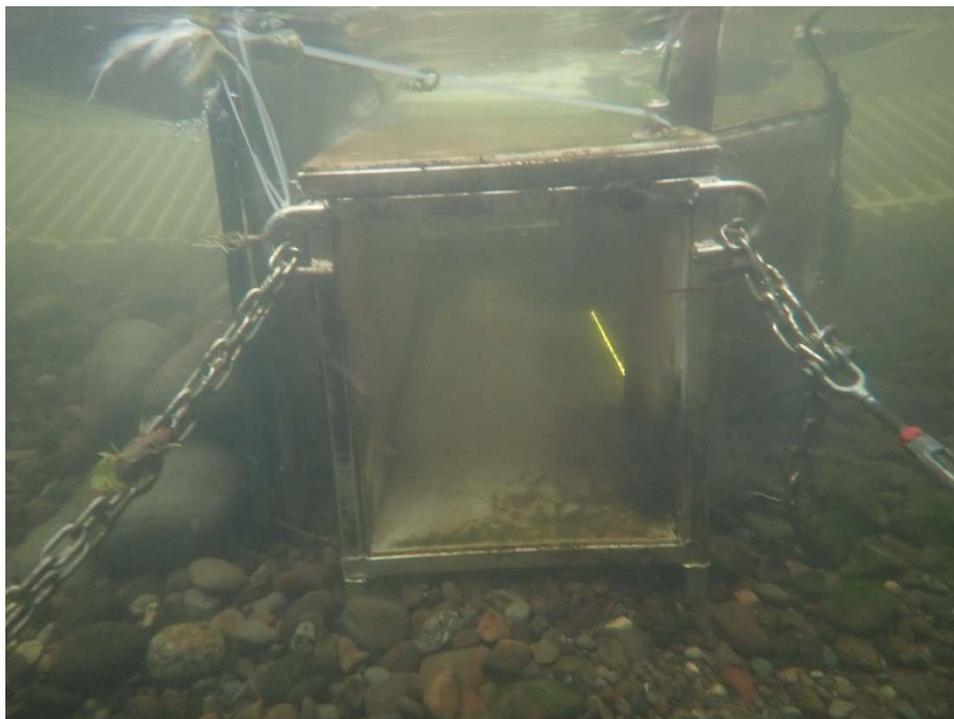
Figure 12. View of the upstream opening of the fish/camera box integrated into the enumeration fence at the Bear River. Note the LED light.

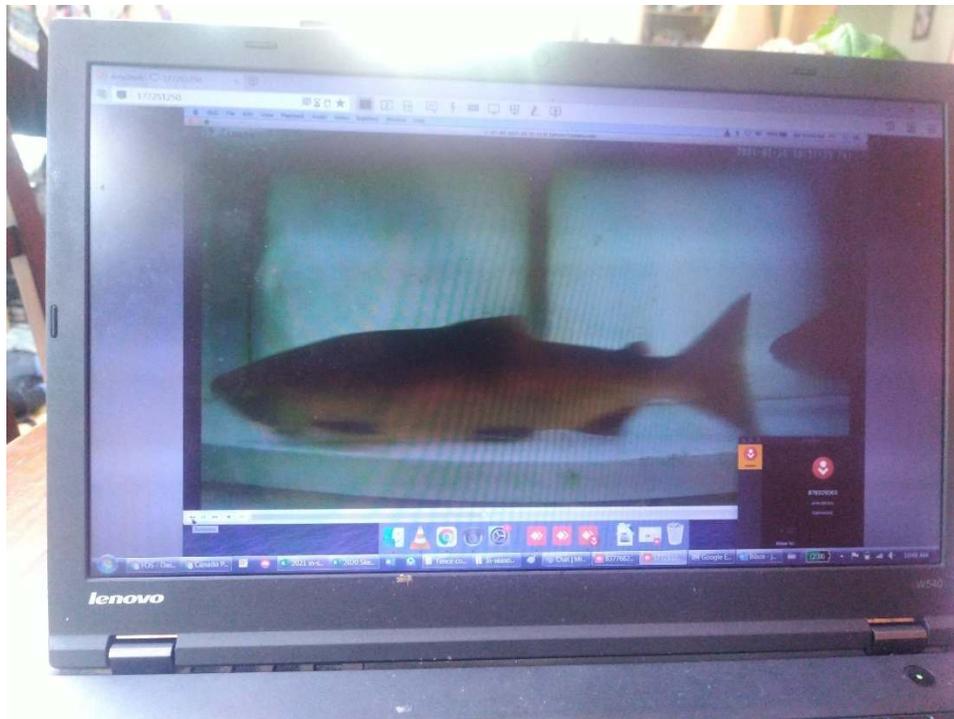
Figure 13. Photo of a sockeye swimming through the fish box at the Bear River viewed on a laptop computer in Smithers, BC via remote communications. July 31, 2021.

The Bear River semi-autonomous salmon enumeration fence recorded the passage of sockeye salmon (Figure 13), large and jack Chinook salmon (Figure 19), pink salmon, coho salmon, steelhead, bull trout, rainbow trout, pigmy white fish and lamprey between July 29th and October 30th, 2021. This report focuses on salmon and steelhead, however total enumeration counts for the other species are presented in Appendix I. Figure 20 shows the daily counts for the salmon species and steelhead. A relatively small number of salmon were enumerated during the first few days of the semi-autonomous salmon enumeration fence operation (Figure 20), suggesting that very few salmon may have migrated through the fence site prior to the installation of the fence. Most of the sockeye migrated over a period of two months, between early August and late September, with two peaks on August 14th and August 25th, however sockeye were also observed in late October (Figure 20). The migration of large Chinook and pink was more constrained in time, with most of the two species recorded within a month, between mid-August and mid-September (Figure 20). Peaks in large Chinook migration were observed on August 14th, August 25th and September 4th. Most coho were observed between mid-August and early October, with a peak on September 21st (Figure 20) Most steelhead were recorded in September and few in October (Figure 20). Finally, Table 1 presents the total enumeration counts for the salmon species and steelhead.

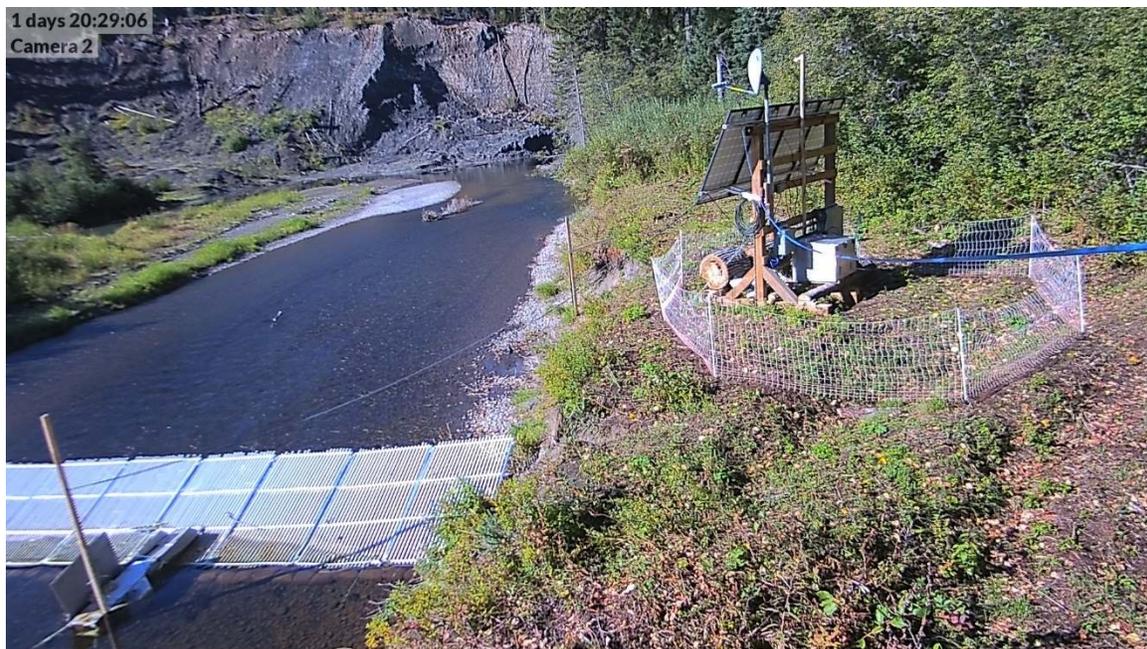
Figure 14. Photo of the fish enumeration fence, fish box, and solar power and satellite communications systems structure taken remotely. August 31, 2021.

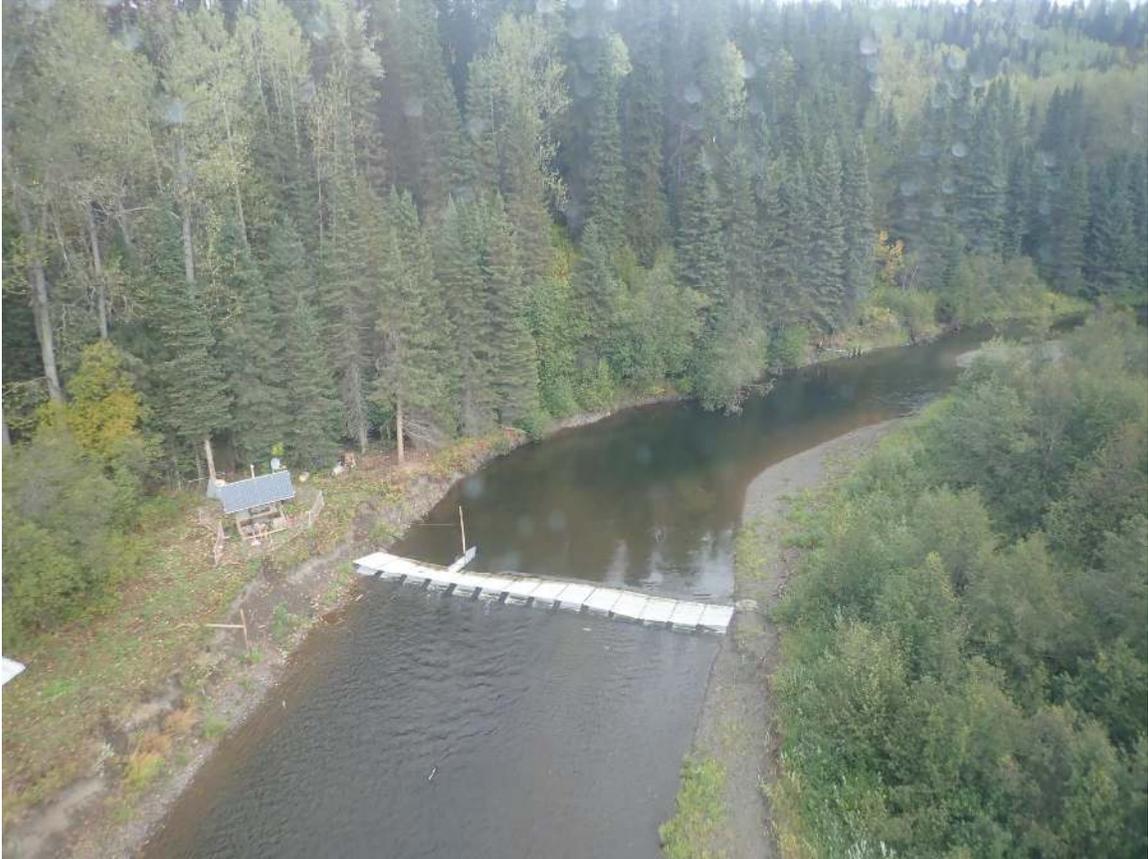
Figure 15. Aerial photo of the semi-autonomous Bear River salmon enumeration site. September 19, 2021.

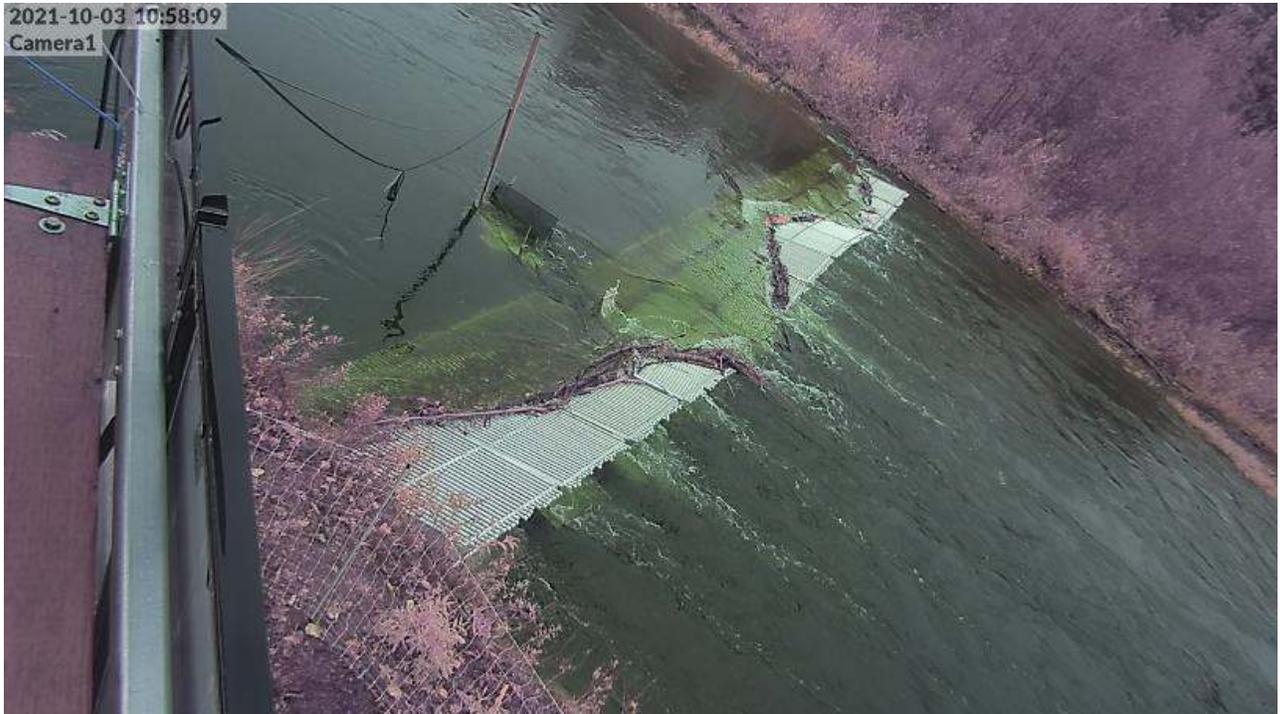
Figure 16. View of the Bear River autonomous salmon enumeration fence during the high-water event in early October 2021. Photo taken remotely on October 3, 2021.

Finally, a major rain event led to significantly high water levels in the Bear River in early October (Figure 16). Despite this significant event, the fence appeared to remain fish tight, and the salmon enumeration and communications systems remained operational.

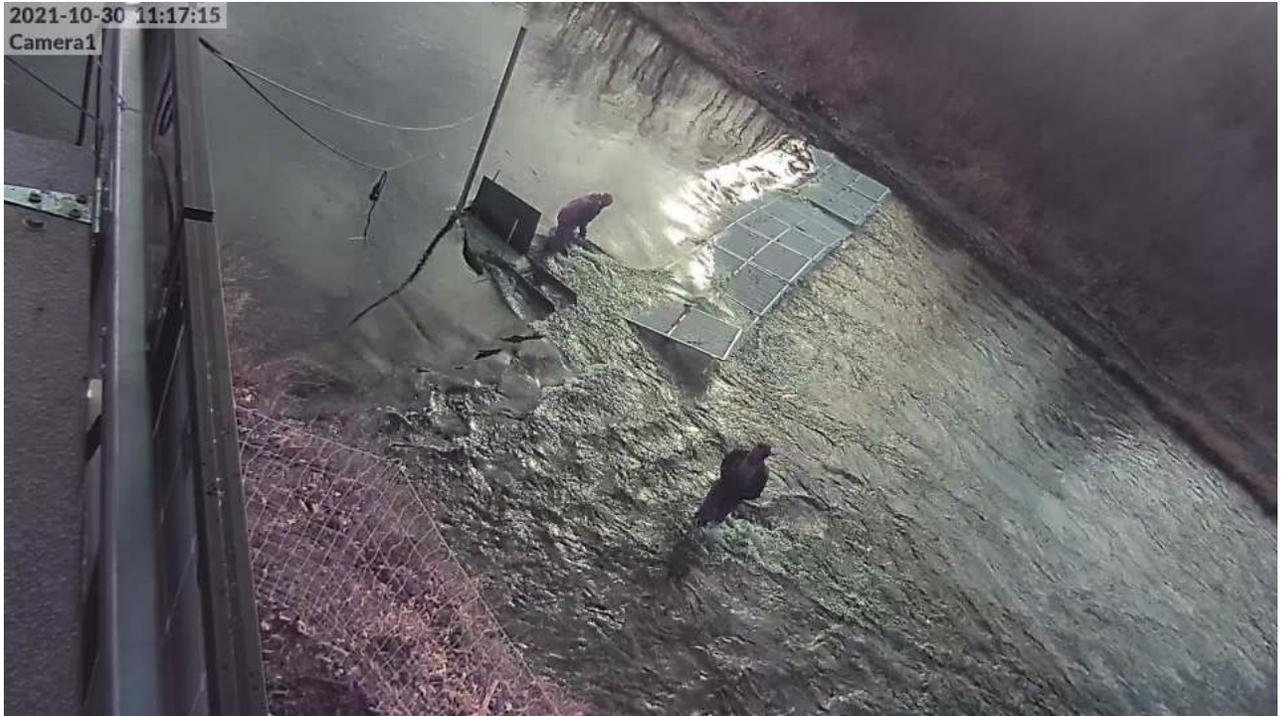
Figure 17. View of a crew removing the Bear River enumeration fence panels. Photo taken remotely on October 30, 2021.

The enumeration fence panels were removed from the Bear River on October 30, 2021 in preparation for the winter (Figure 17). Only the steel I-beam fence sill remained in the river. The solar power and communications systems structure was also left in place for the winter and remained operational to monitor the voltage of the battery bank over-winter. The only modifications that were made to the structure were the vertical positioning of the solar panel to better shed snow (Figure 18), and the addition of insulation foam to protect the battery bank from the cold.

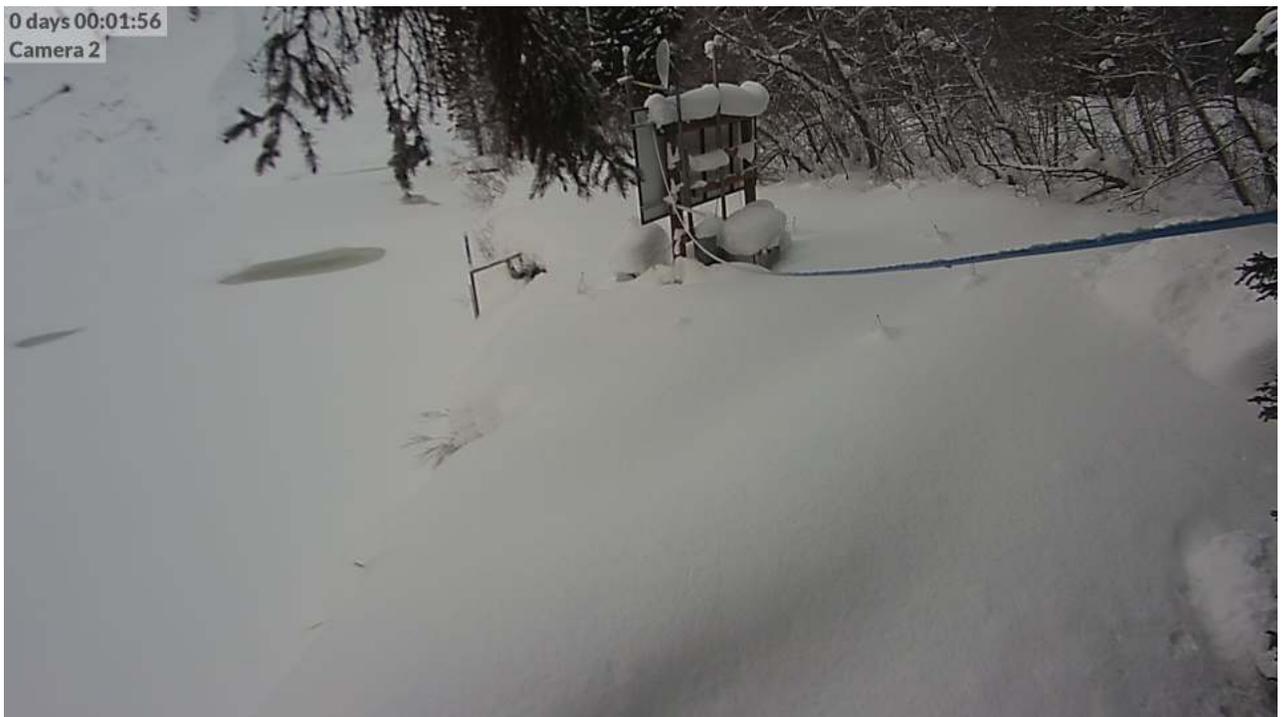
Figure 18. View of the solar power and communications systems structure at the Bear River during winter. Photo taken remotely on January 13, 2022.

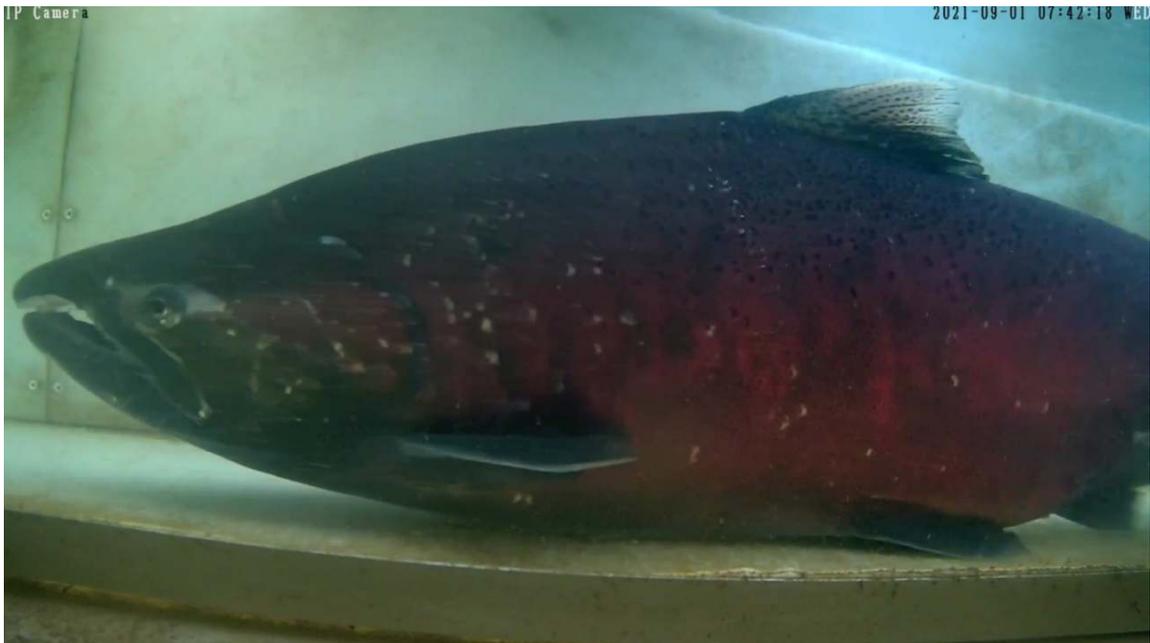
Figure 19. View of a large Chinook migrating through the fish/camera box at the Bear River semi-autonomous salmon enumeration fence. September 1, 2021.

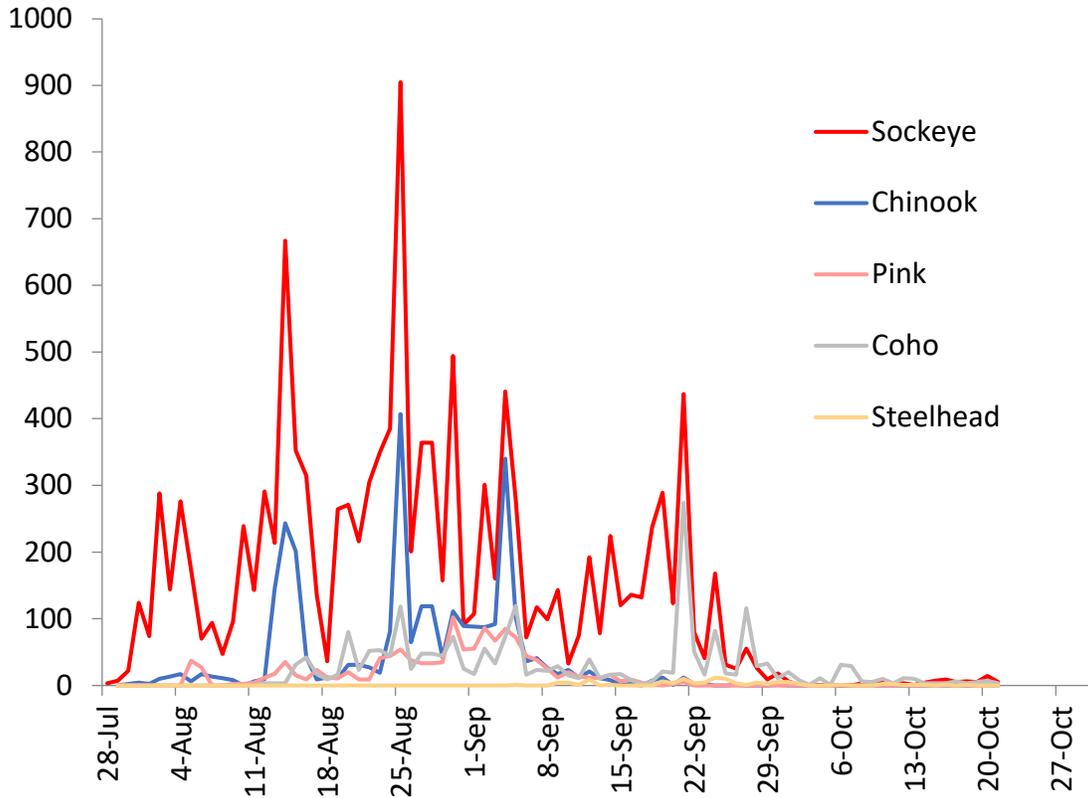
Figure 20. Daily counts of sockeye, Chinook (large), pink and coho salmon, and steelhead through the Bear River semi-autonomous salmon enumeration fence in 2021.
